# GUARD AGAINST VIBRATION DAMAGE

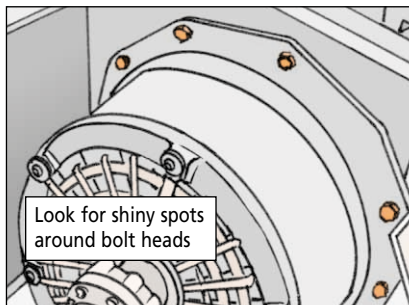
**T**hat old enemy, vibration, is claiming yet another victim: the vane axial fan on your MLRS carrier. Stress and vibration can cause one or more of the fan's mounting bolts to loosen or snap. If that happens, even more stress is put on the remaining bolts. Eventually, the vane axial fan can fall off.

During your PMCS, eyeball the mounting bolts closely. If you spot signs of loosening (shiny spots around the bolt heads) or missing bolts, report 'em.

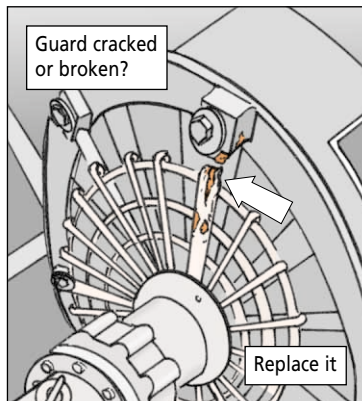
While you're there, take a look at the fan drive guard, too. Vibration can weaken and snap the guard at its mounting bolts. When that happens, the guard can fall into the fan blades.

Look for cracks or breaks to the guard and report any you see. Your mechanic can replace a damaged guard with NSN 4140-01-315-3959.
